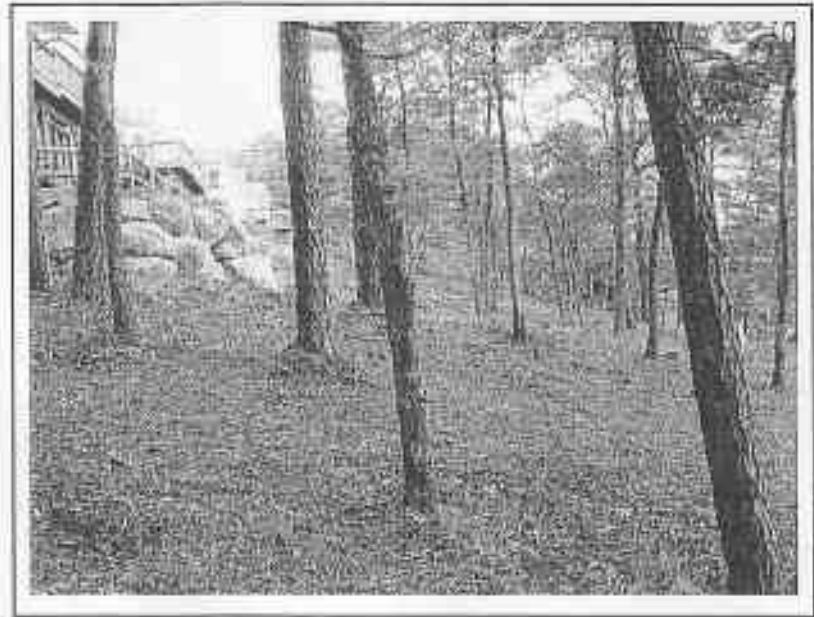
Photo 1:

View looking north at the area where under-story and mature trees were previously removed. This area is within the 100-foot buffer zone to Great Island Lake. For restoration purposes this area has been identified as Disturbance Area B in the Restoration Plan and will be restored with plants as listed in this same plan.

(Photograph taken on October 2, 2007)

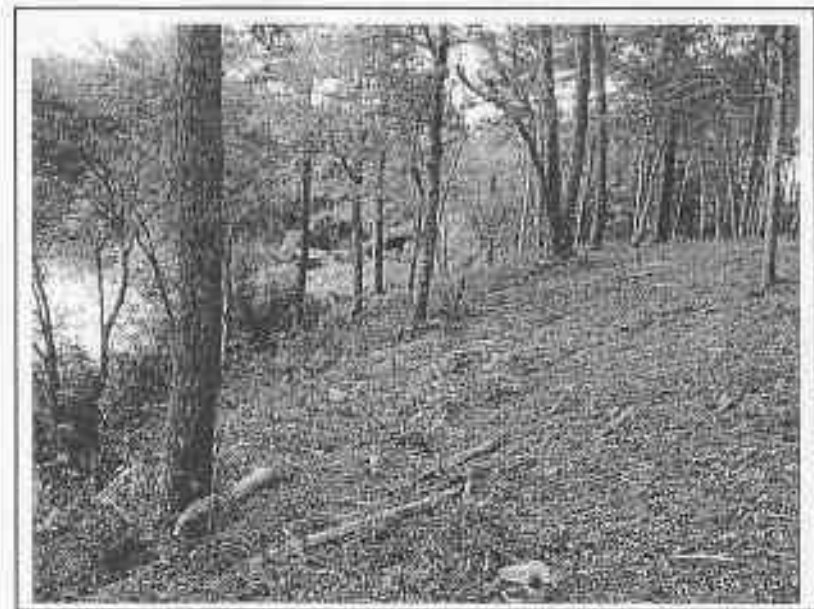
Photo 2:

View looking south at the area where vegetation was removed. Note that the vegetation at the edge of Great Island Lake was not removed during the clearing activities.

(Photograph taken on October 2, 2007)

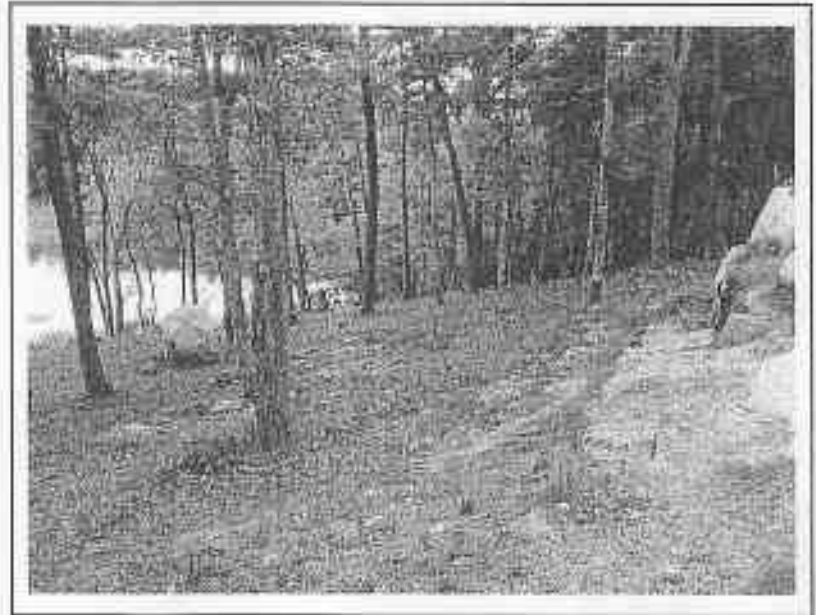
Photo 3:

View looking south along Great Island Pond at the area of disturbance. The large boulders illustrated on the right side of the photograph are associated with the embankment to the houses along White Trellis. These boulders are also the approximate upper edge of the 100 foot buffer zone to the bank of Great Island Pond.

(Photograph taken on October 2, 2007)

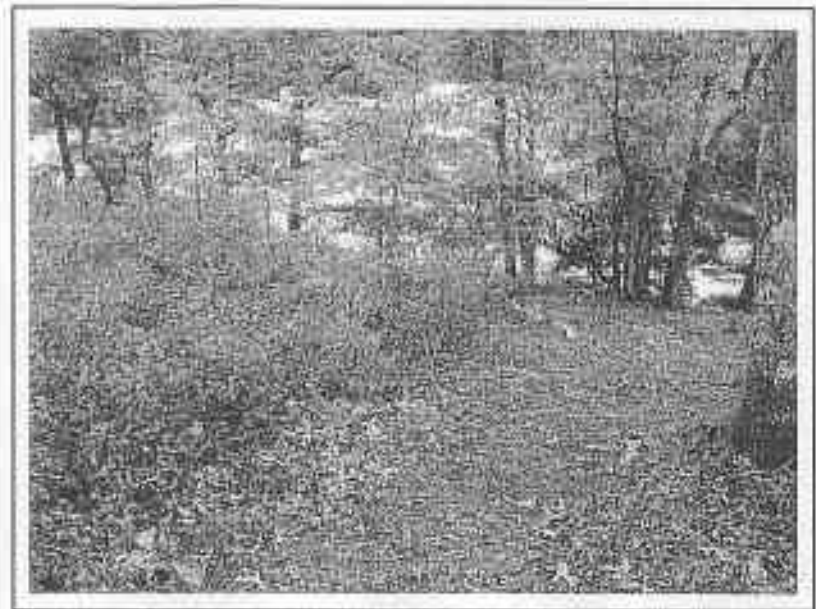
Photo 4:

Photograph of the edge where clearing was halted. Previous to the clearing, the under-story was dominated by huckleberry (*Gaylussacia baccata*). As this plant is not commercially grown, it is not included in the plant lists. However, the area was not grubbed and the root mass for this plant was left intact. It will likely re-grow with time.

(Photograph taken on October 2, 2007)
